AMRL-TR-77-60

F/FB-111 ESCAPE INJURY MECHANISM ASSESSMENT

LEON E. KAZARIAN

OCTOBER 1977

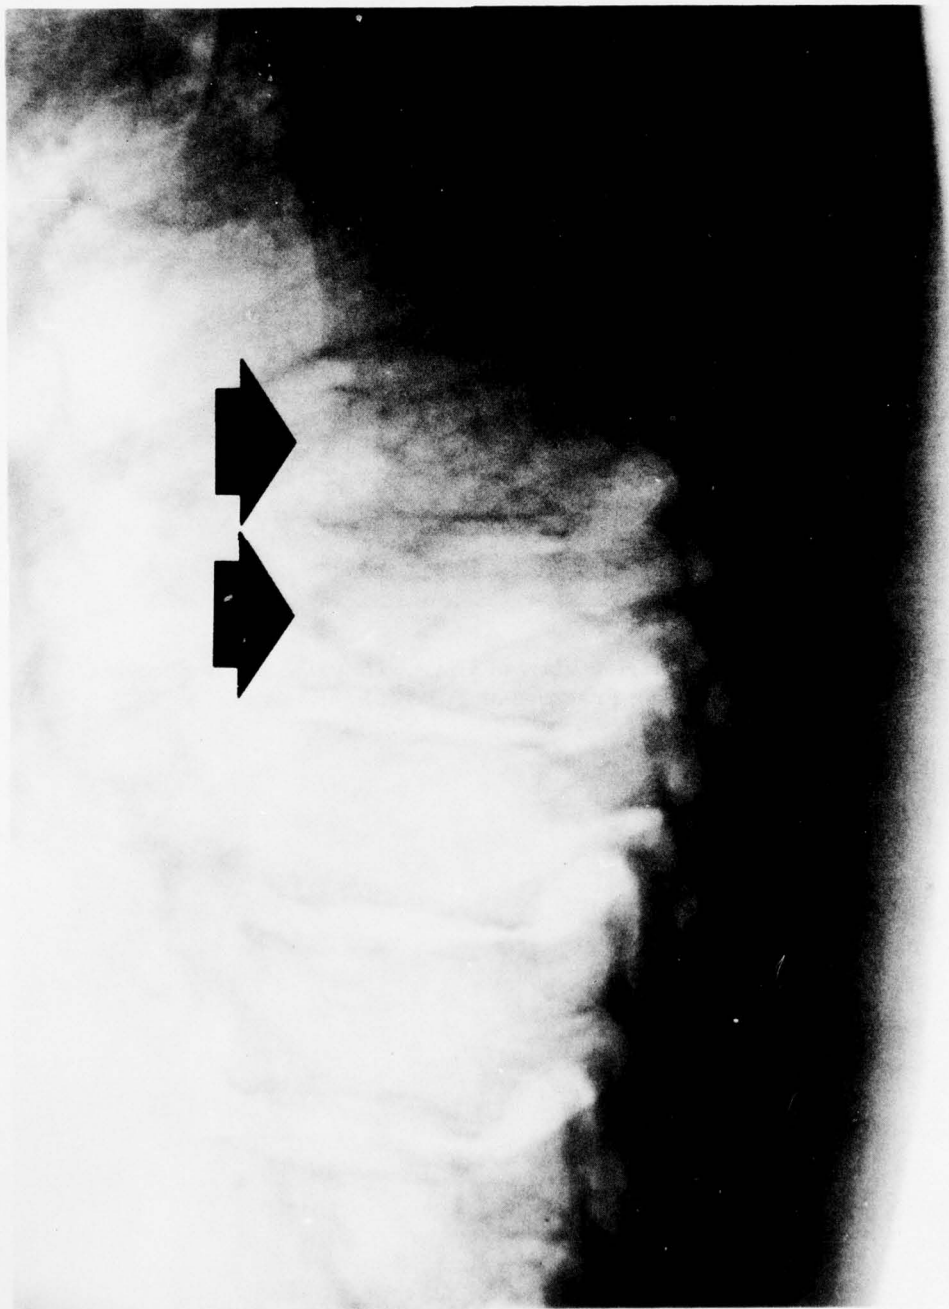
Analysis of routine anterior-posterior and lateral roentgenograms revealed mild anterior wedge compression to be the most common form of fracture, as illustrated in Figure 4. Vertebral column splaying as shown in Figure 5 was occasionally observed. Fragmentation and/or separation of the anterior superior marginal ring of the vertebral body was occasionally suspected. Fractures seemed to be most prevalent in the mid-lower thoracic spinal column.

**Figure 4. Lateral View of Upper Thoracic Spine
[Mild Anterior Wedge Compression Fractures (Arrow)]**

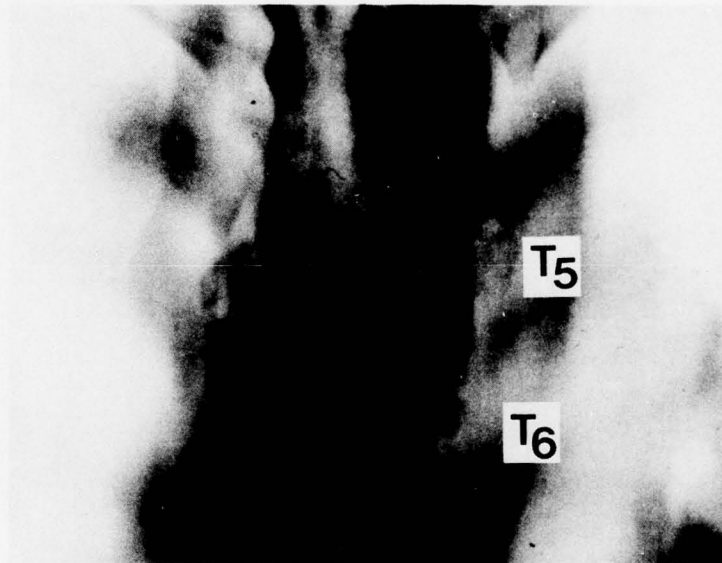
**Figure 5. Anterior/Posterior View of Upper Thoracic Spine Showing
A Splaying Fracture at T₅ With Scoliosis**

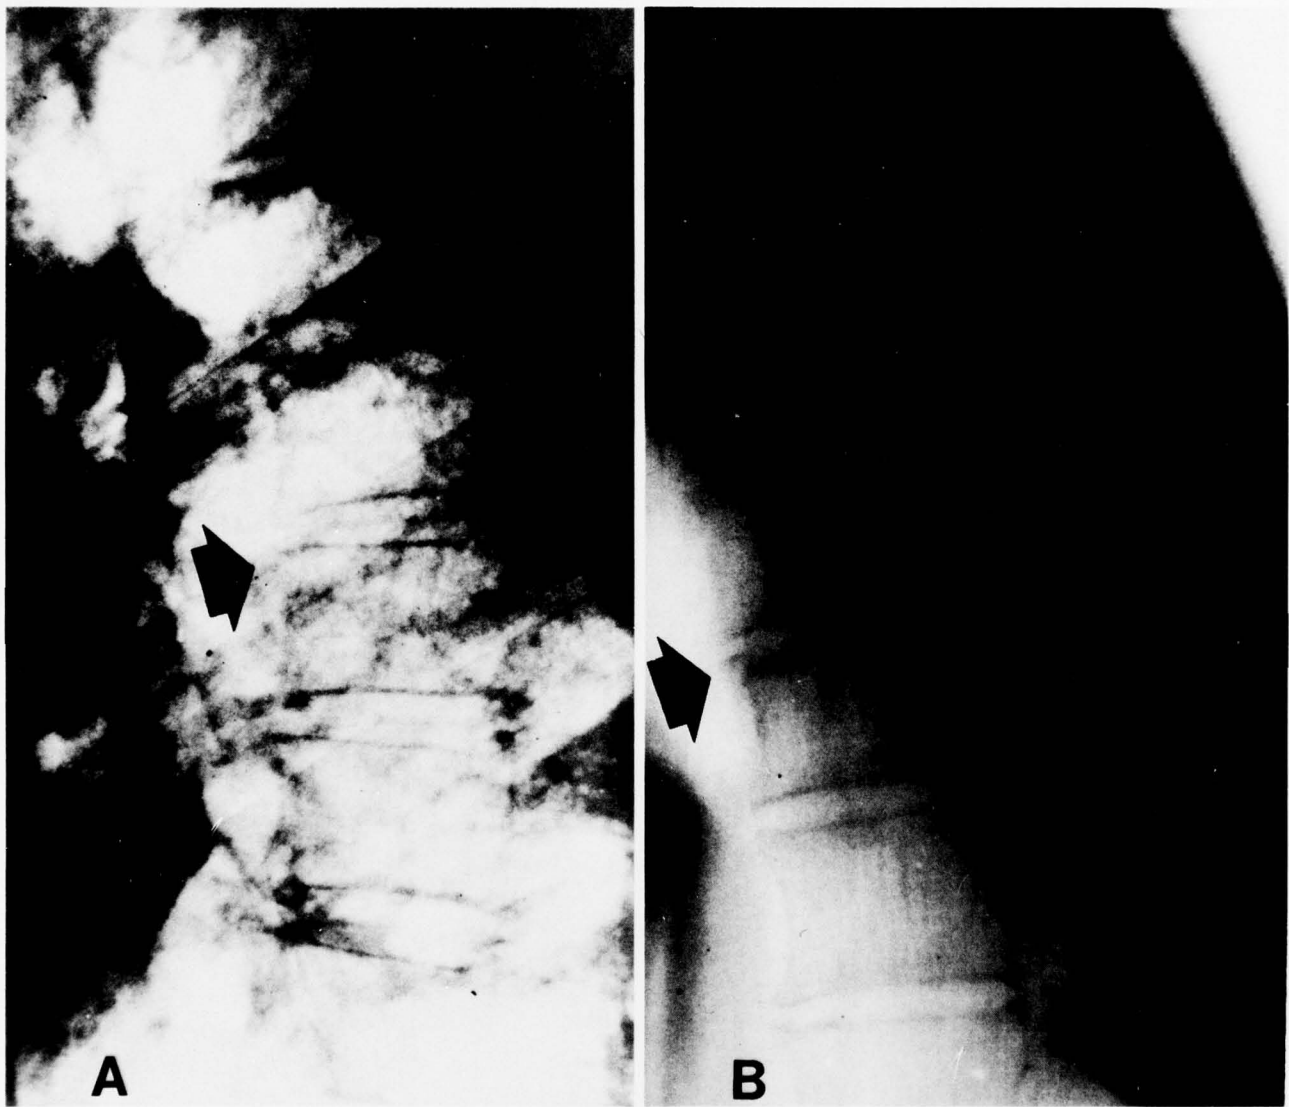
Figure 6. Example of a Routine Radiograph (A) Versus Tomographic View (B)
[The Injury Identified by the Arrow in the Tomograph is Not Apparent on the Routine Radiograph]

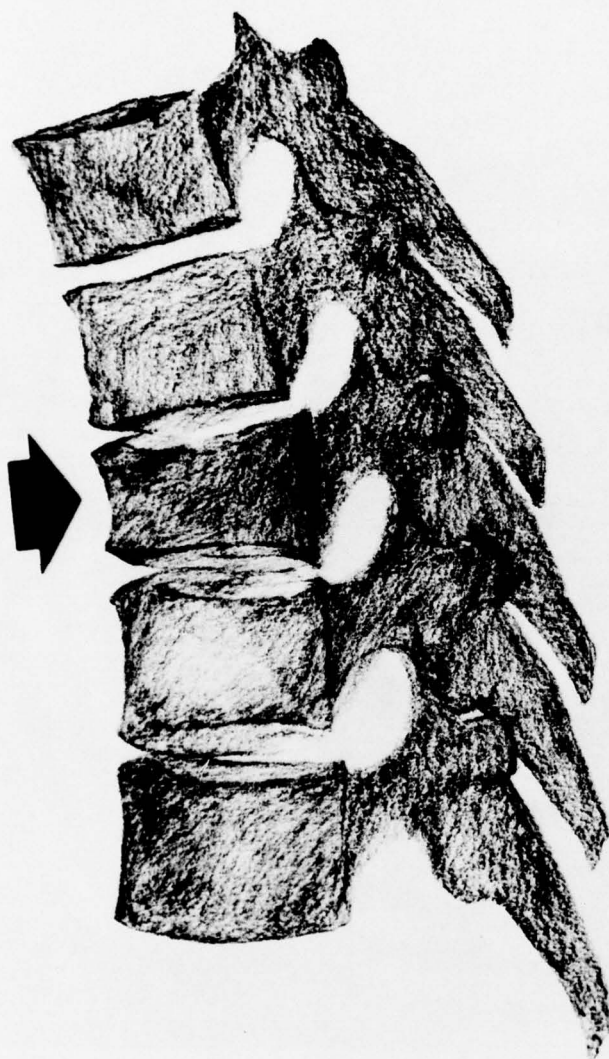
Figure 7. Lateral View of Upper Thoracic Spine Illustrates a Loss in Continuity of the Posterior Vertebral Centrum Curvature and a Mild ($< 10\%$) Loss in Vertebral Centrum Height (Arrow)

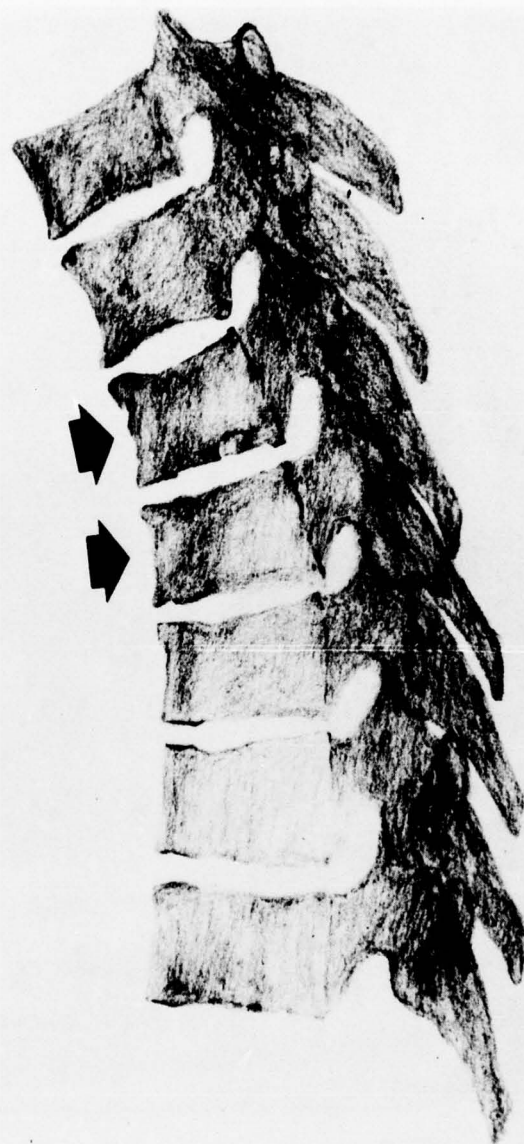
Figure 8. Lateral View of Upper Thoracic Spine Illustrates Anterior Wedge Compression Fracture (Arrows), With Approximation of Posterior Vertebral Centrum Height

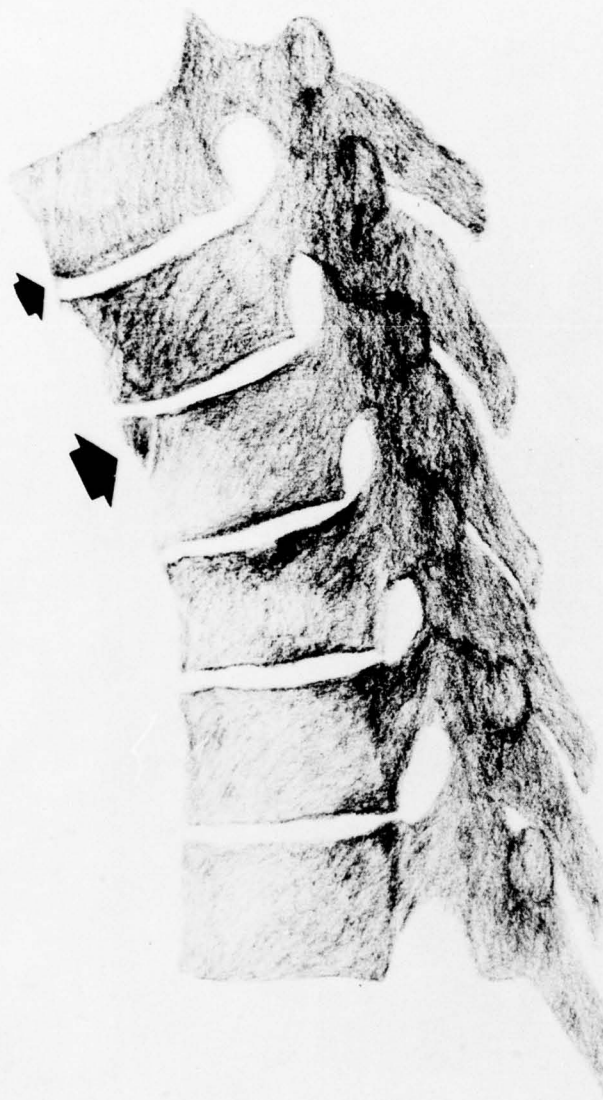
Figure 9. Lateral View of the Upper Thoracic Spine Illustrates Loss in Anterior Vertebral Centrum Height at T₆ [Disruption of the Anterior Superior Marginal Ring at the T₅-T₆ Level (Arrows)]

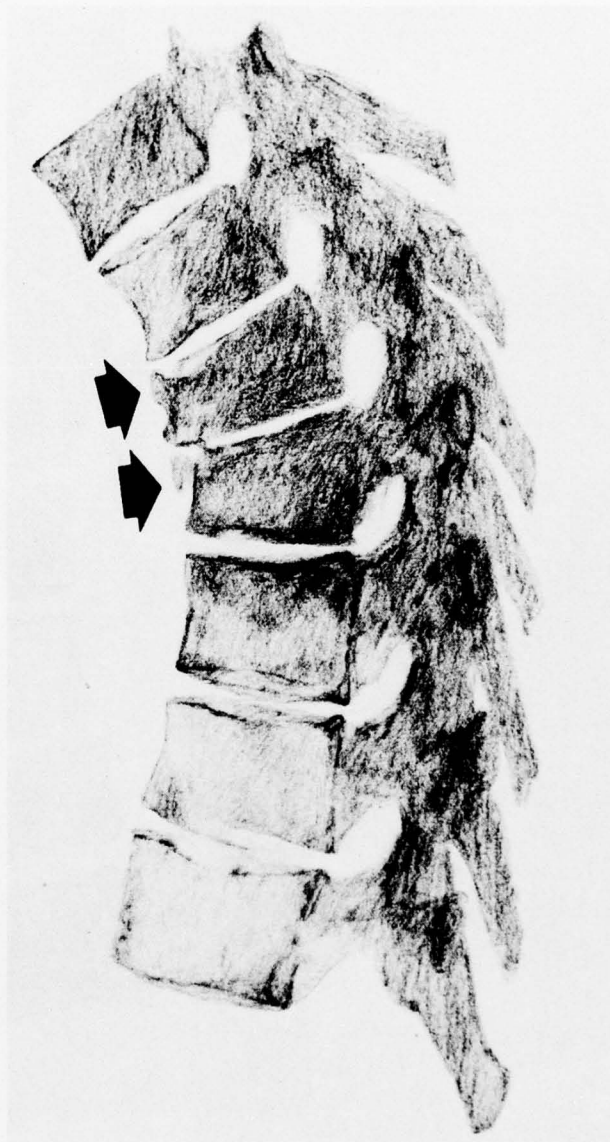
Figure 10. Lateral View of the Upper Thoracic Spine Illustrates Loss in Anterior Vertebral Centrum Height at Two Levels [Disruption of the Anterior Superior Marginal Ring at T₆ and T₇ (Arrows)]

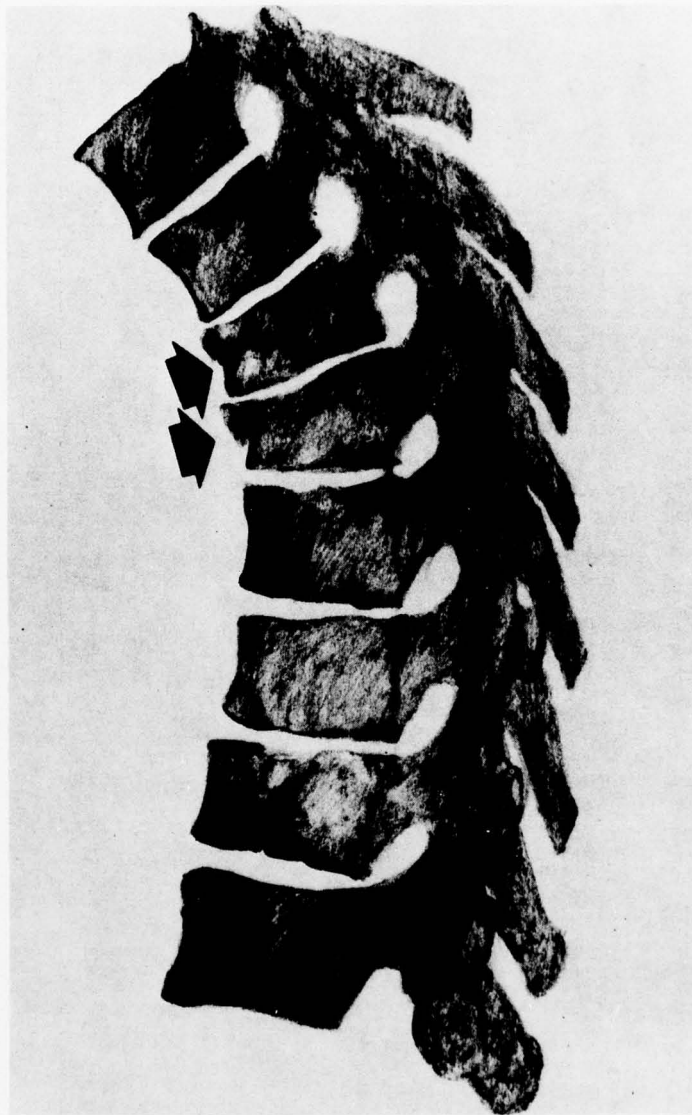
Figure 11. Lateral View of Upper Thoracic Spine Illustrates:
(1) **Disruption of the Posterior Vertebral Body Height and Continuity at T₅ and T₆**
 (Top Arrow)
(2) **Avulsion Fracture at T₆ (Bottom Arrow)**

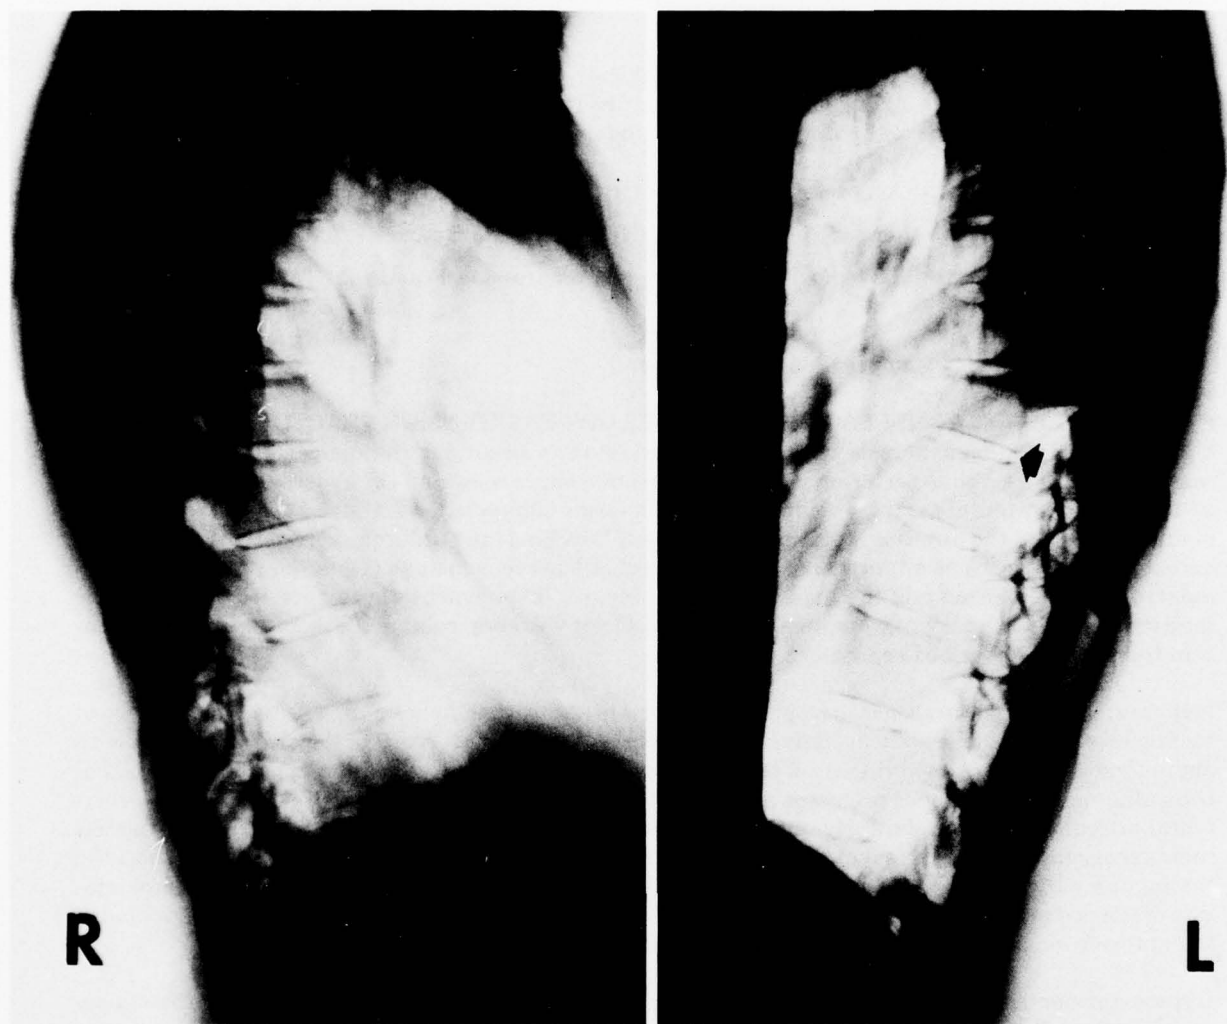
14 A

Figure 14A. Radiographs of Right and Left Lateral View of the Upper Thoracic Spine Revealing Asymmetrical Approximation of Posterior Vertebral Centrum Heights at the Level of T₄-T₅-T₆-T₇

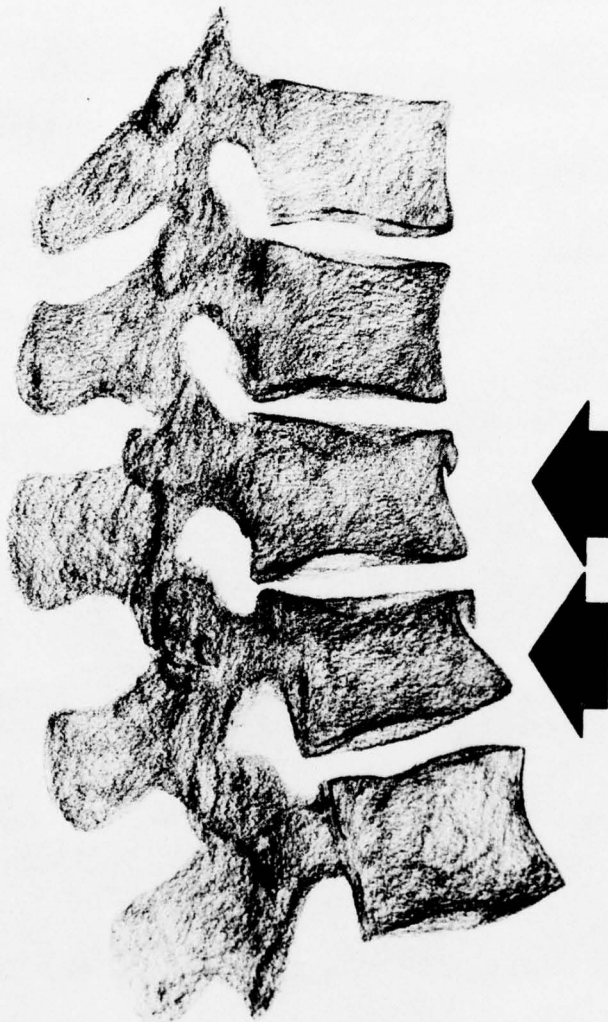
Figure 15. Lateral View of the Upper Thoracic Spine Illustrates Asymmetrical Vertebral Centrum Approximation with Minimal Avulsion of Anterior Longitudinal Ligament (Arrows)

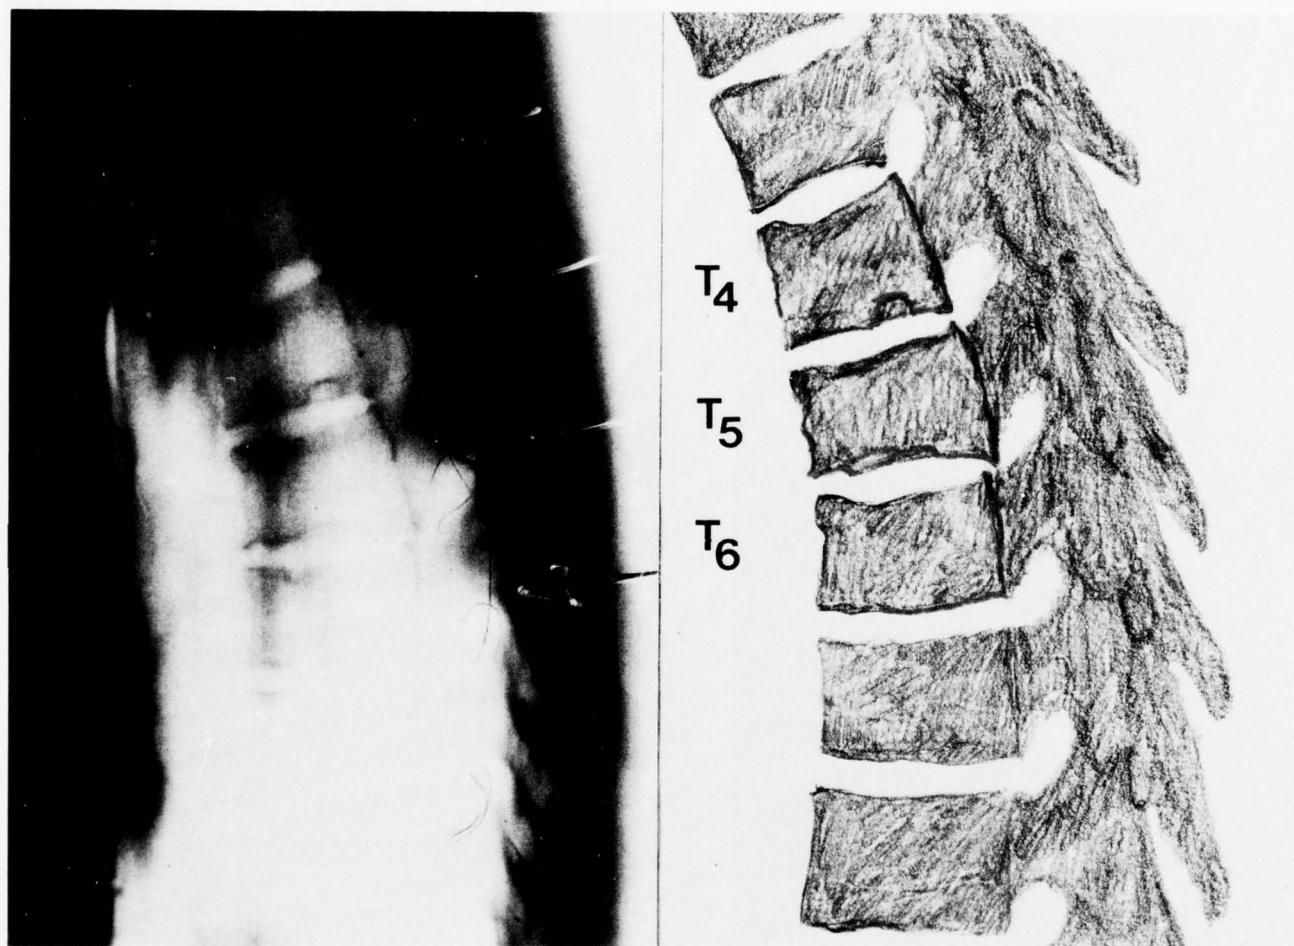
Figure 16. Lateral View of Upper Thoracic Spine Illustrates Narrowing of Intervertebral Disk Space Heights at the T₄-T₅-T₆ Levels With Bony Bridging or Contact of Posterior Adjacent Vertebral Centrum Heights

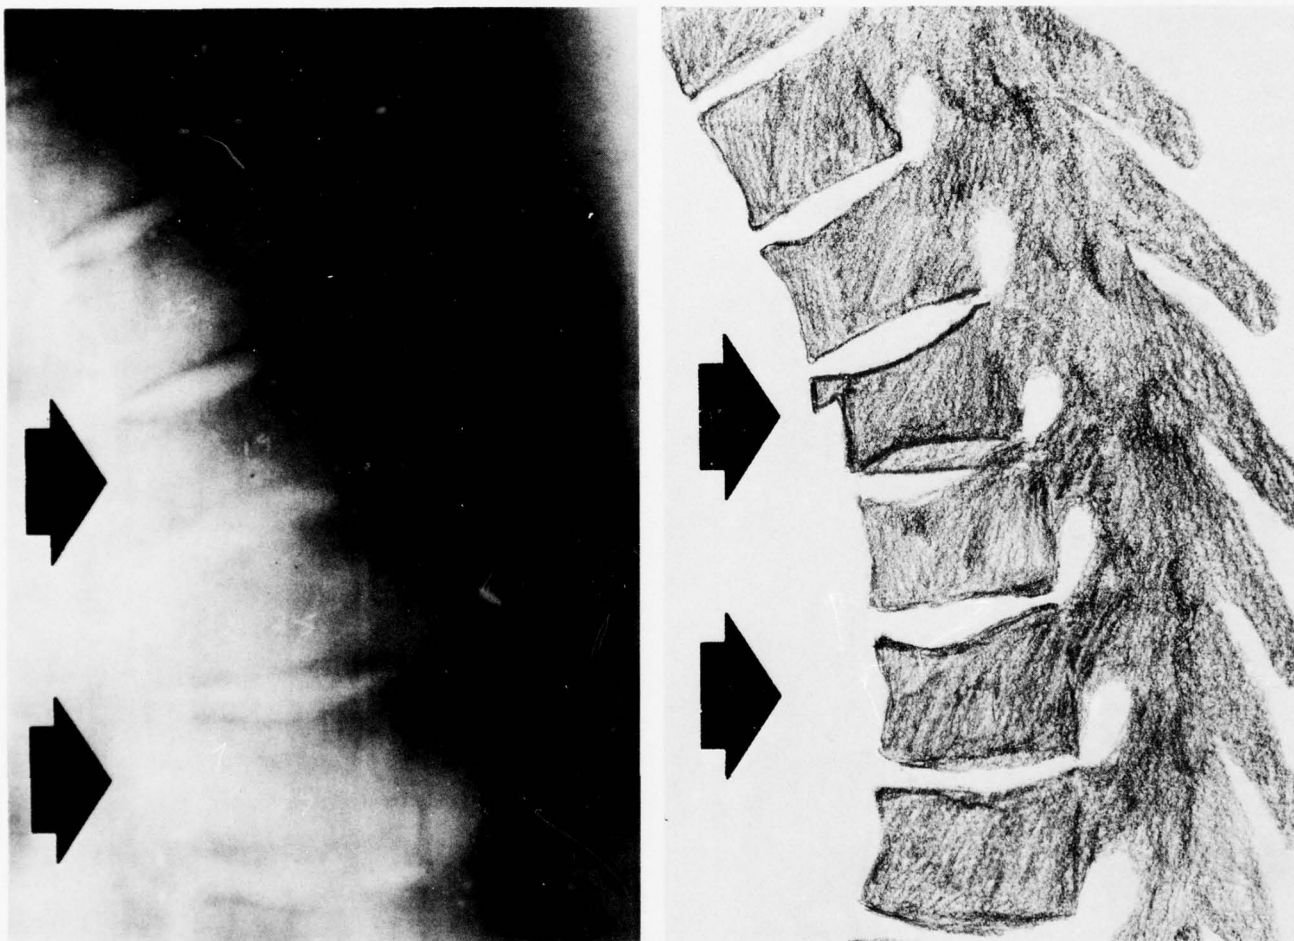
Figure 17. Lateral View of Upper Thoracic Spine. Avulsion Fracture of the Anterosuperior Segment of T₆ and T₈

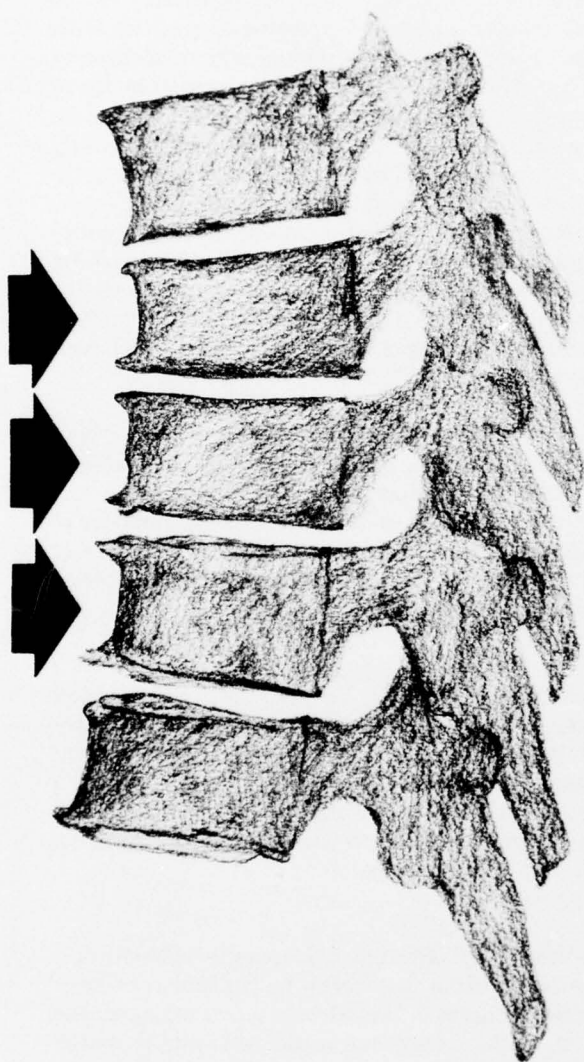
Figure 18. Lateral View of Upper Thoracic Spine Illustrates Uniform-like Collapse of Vertebral Centrum Height

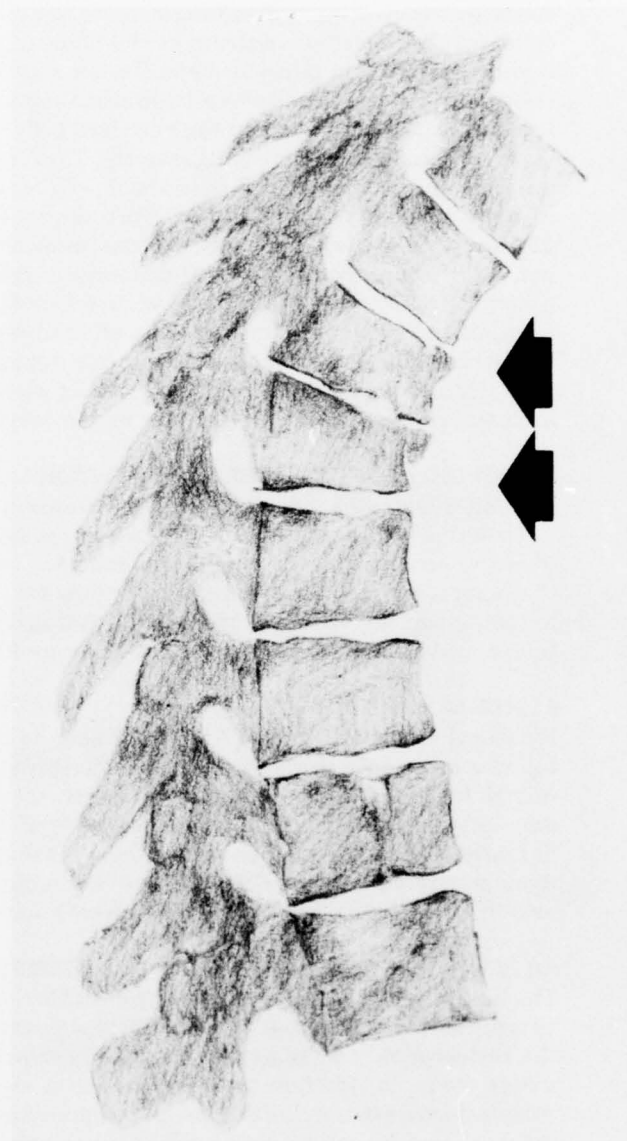
Figure 19. Lateral View of Upper Thoracic Spine Illustrates Anterior Vertebral Centrum Collapse at Two Levels

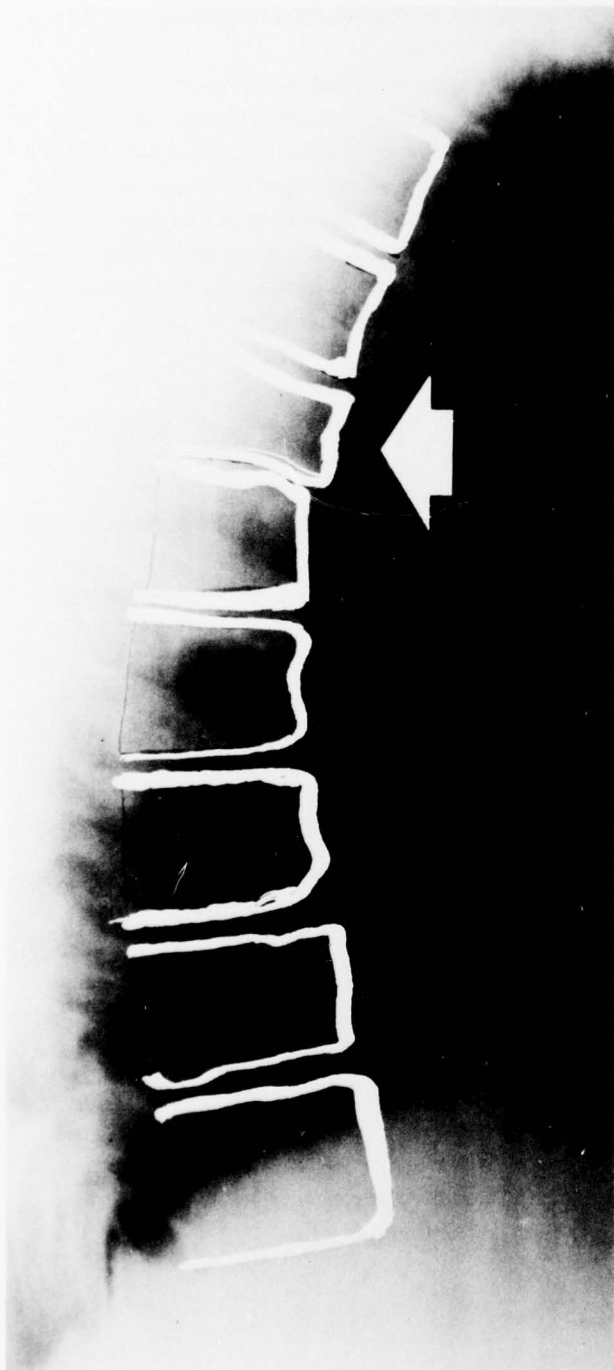
Figure 20. Lateral Radiograph Shows Combined Anterior Wedge Compression Fracture and Disruption of Posterior Vertebral Column

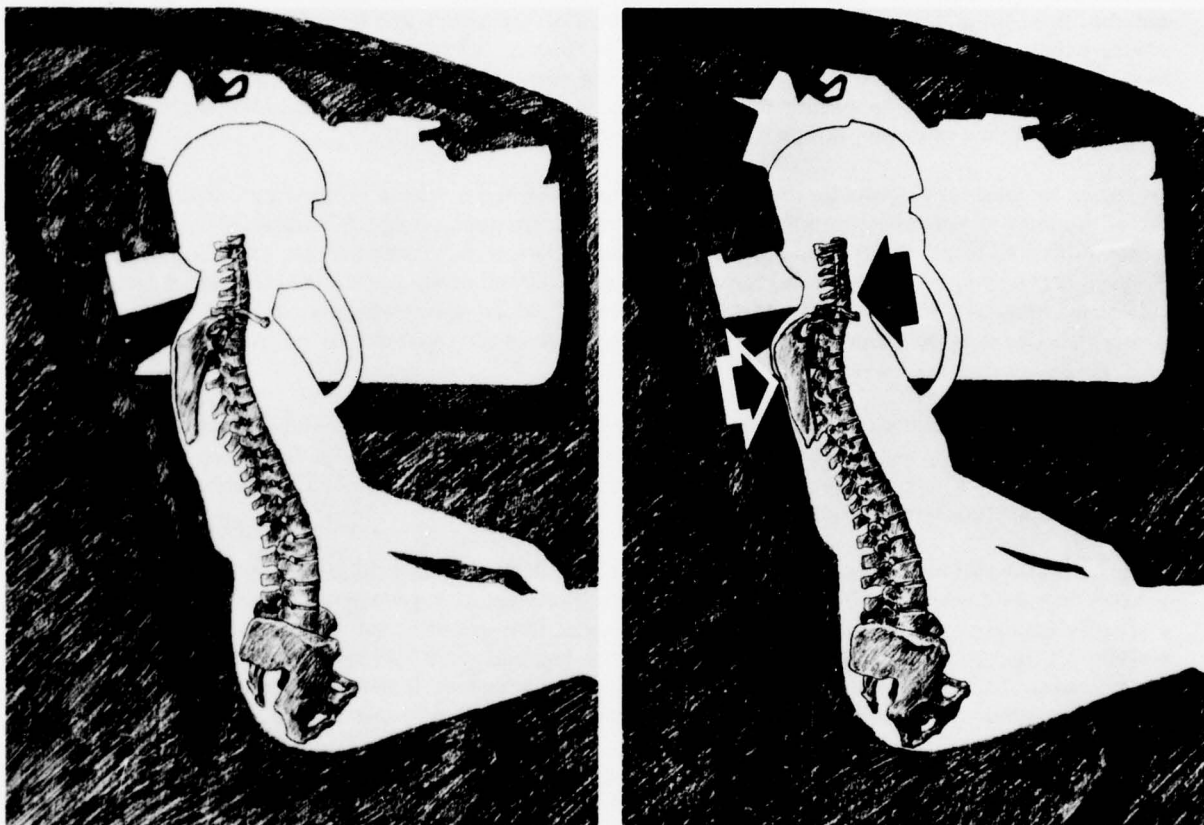
All hyperextension injuries were categorized in terms of seat geometry with respect to aircrew anthropometry, type, and severity of spinal injury. The sequence of injury was found to be as follows: on powered inertia reel retraction, the horse collar was dragged across the upper surfaces of the clavicles applying a rearward, arcing force on the acromioclavicular joints while at the same time placing the sternoclavicular joints in tension, as illustrated in Figure 23. The upper torso reacted to the retraction force by forcing the scapulae into the posterior chest wall, which restrained and locked the ends of the upper ribs into the T₁-T₇ vertebrae. Thus, the backrest formed a fulcrum for the upper position of the thoracic spine to arc into the void between the seat back and headrest. This injury is due primarily to normal thoracic kyphosis dearcing. The sequence of events required to produce this injury mode are illustrated in Figure 24.

Figure 24. Arcing Hyperextension Injury of Upper Thoracic Spine, a Fulcrum is Formed by the Seat Back as the Powered Inertia Reel Decreases and Reverses Thoracic Kyphosis. Left: Normal Torso Position. Right: Inertial Reel Retracted.

If the position and/or the geometry of the inertia reel and the shoulder strap anchor points are raised upwards above a crewman's shoulders, both injury modes will be significantly reduced. At the time of this writing, a statement of work has been written, and a program will be started in August 1977 to correct the design deficiencies in the support and restraint system that will significantly reduce the back injury problem.

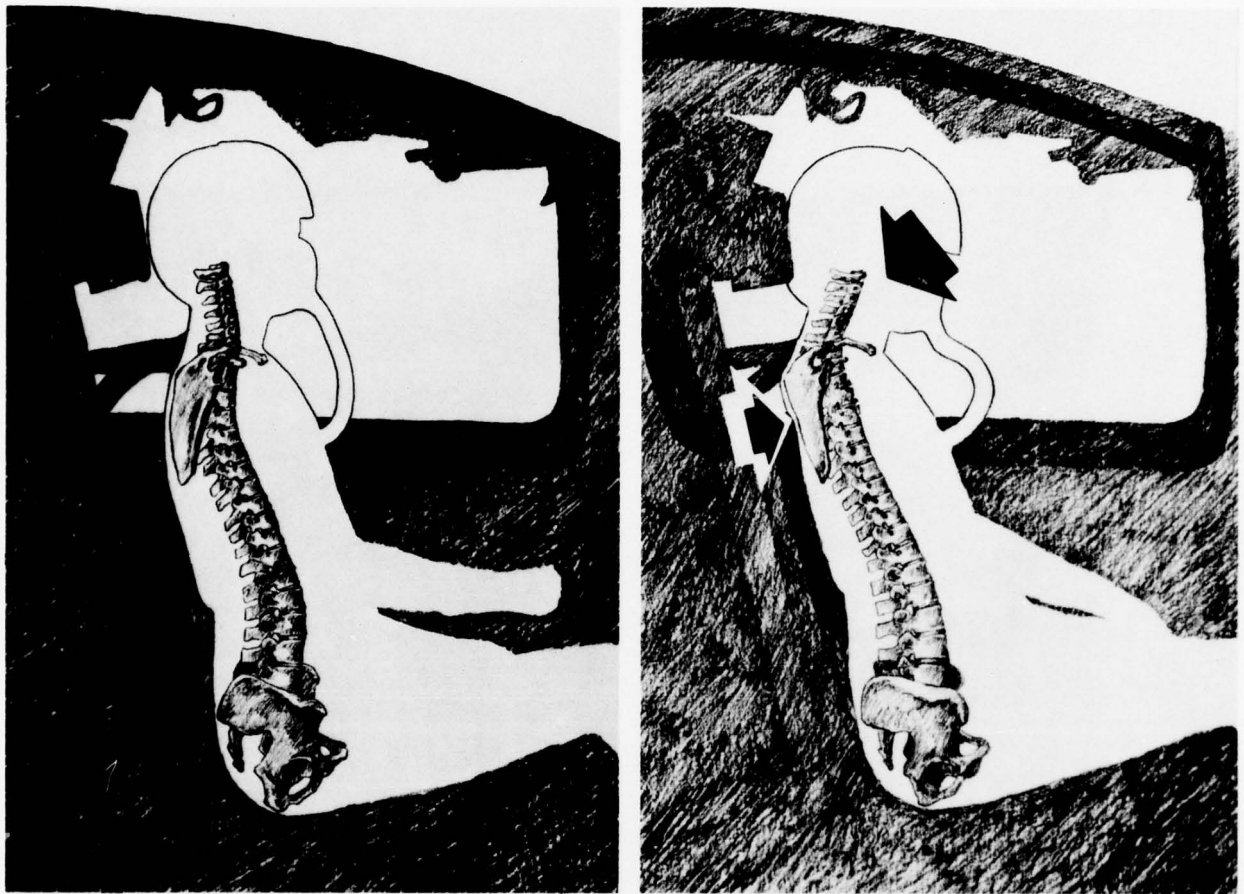
A second hyperextension injury mode was also identified. As in the injury mode just described, the normal curvature of the thoracic spine is reversed placing the anterior longitudinal ligament in tension; however, in this second hyperextension injury mode, there occurs simultaneously a downward, rearward, medially-directed load inward that causes posterior vertebral centrum compression in the mid-thoracic column. In addition, the spinous processes and articular processes are forced together and act as a fulcrum, causing the anterior longitudinal ligament to rupture. It has been strongly suspected that separation has occurred between the cancellous bone of the vertebral body and the adjacent cartilaginous end plate. Fractures of the accessory processes have occurred without fractures to the vertebral body. This second hyperextension injury mode is illustrated in Figure 25.

Figure 25. Arcing Hyperextension Injury of the Upper Thoracic Spine with a Downward Rearward Component (A Fulcrum is Formed by the Scapulae on the Seat Back While the Powered Inertia Reel Decreases, Reverses, and Pulls Downward on the Thoracic Spine) Left: Normal Torso Position. Right: Inertia Reel Retracted.

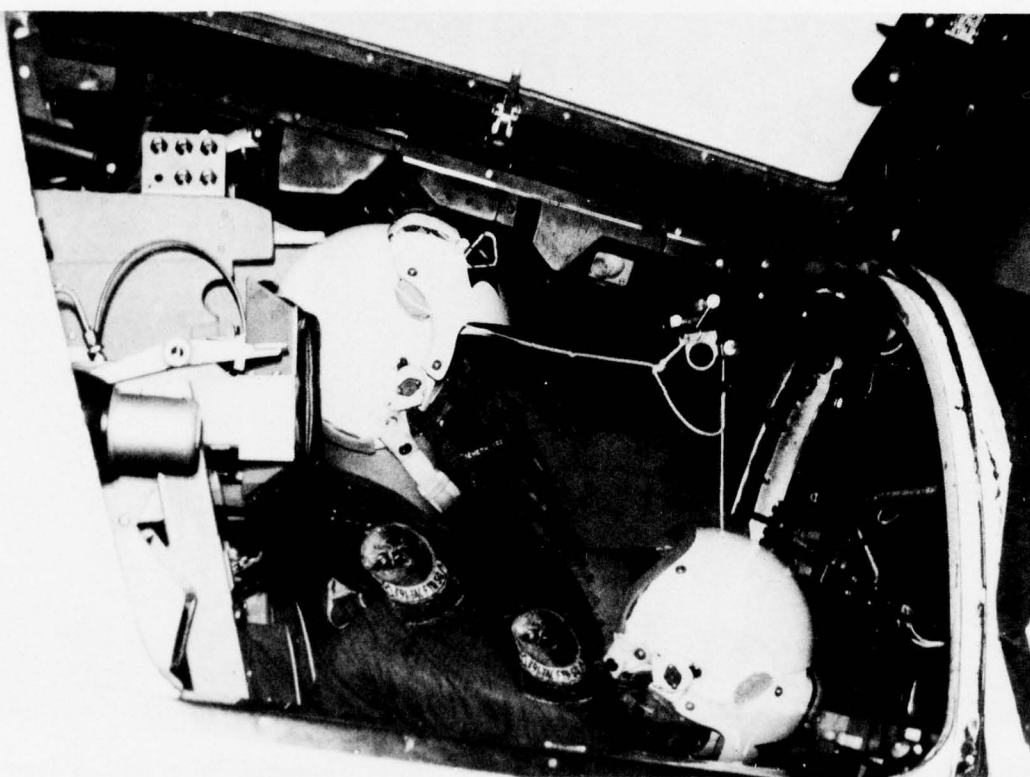
The current F/FB-111 restraint geometry does not provide optimum overall protection in the crew module environment. The position and action of the inertia reel and the shoulder straps anchor position have compromised, to the worst possible degree, the support and restraint offered by this system.

Figure 26. The Configuration of the Restraint System Allows an Aircrewman to Rotate Within the Fixed Geometry of the Fully Retracted and Locked Restraint Harness. The Amount of Rotation is Shown.

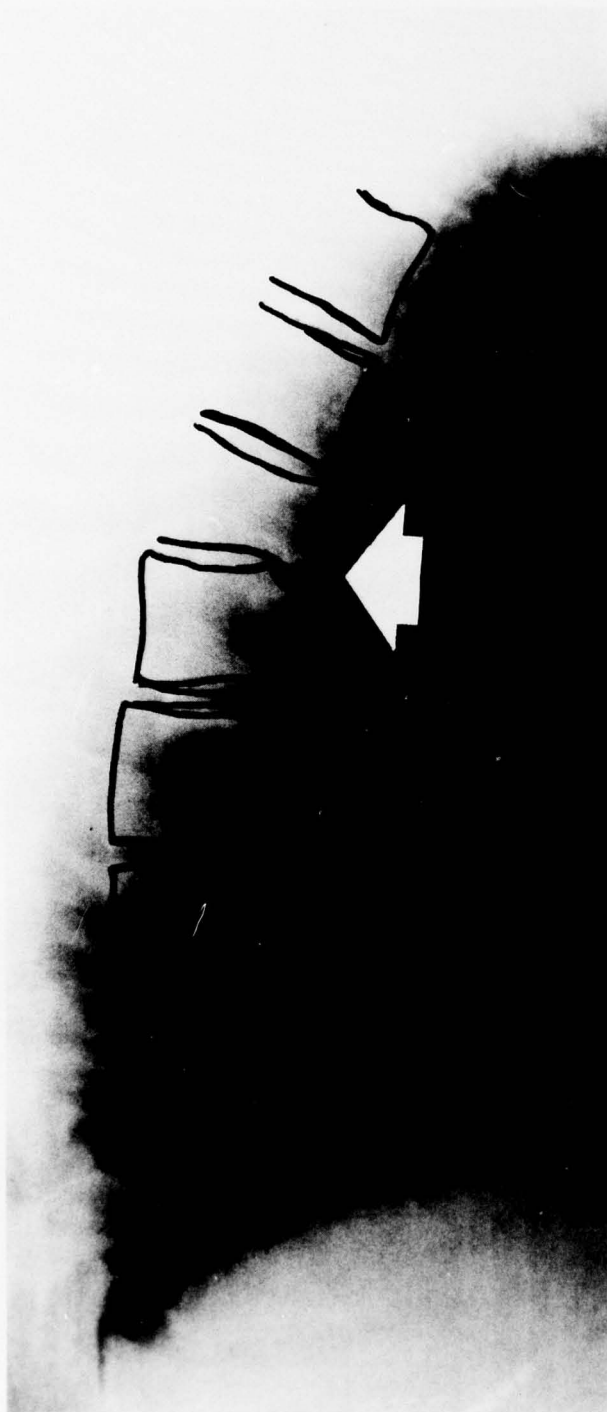
Figure 31. Lateral View of Thoracic Spine Shows Ground Landing Impact Injury (Subject PA)

Case I — Subject PA sustained a Type 3C injury after ejection. The injury is shown in Figure 31. He was placed in a body cast for 6 weeks. Following this period, the cast was removed. Roentgenograms showed good vertebral column alignment. Intervertebral disk space was maintained as shown in Figure 32. Four months after ejection injury, additional radiographs were taken. A kyphotic angulation along with a decrease in intervertebral space height and further vertebral body compression were found (Figure 33). Eighteen months following ejection, radiographs were repeated; Figure 34 shows that the spinal level of involvement at this period of time was in the process of undergoing a spontaneous anterior fusion with a permanent gibbus deformity.

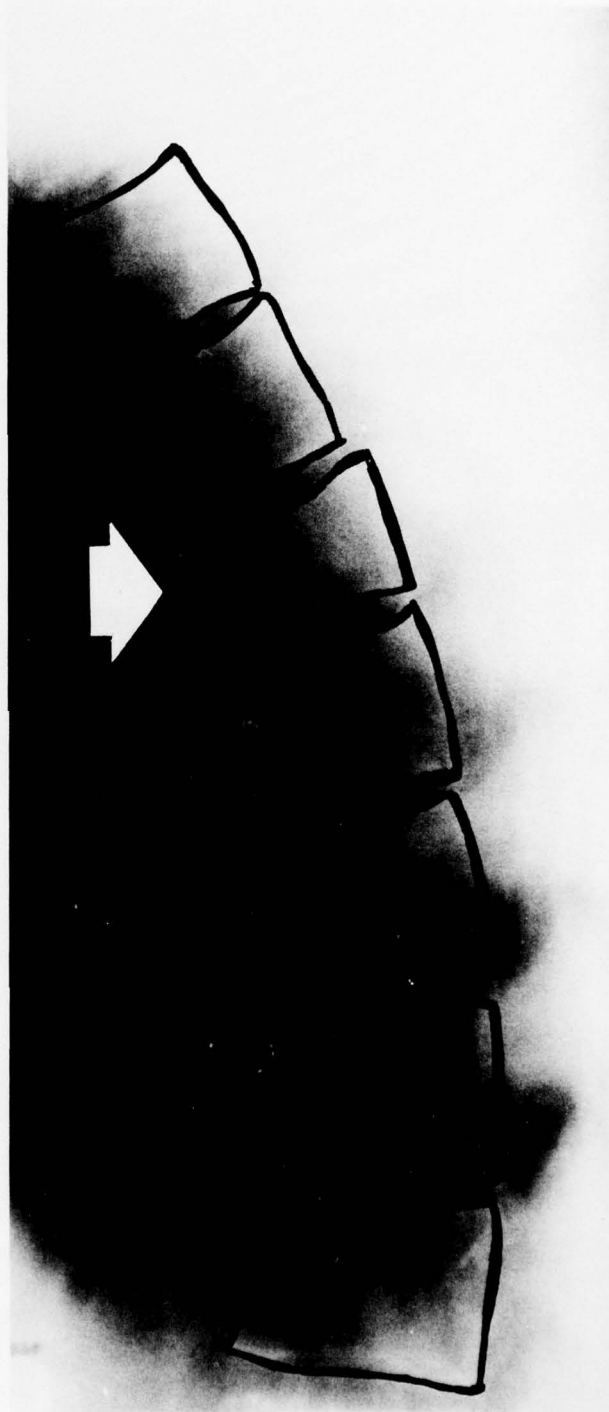
Figure 32. Lateral View of Thoracic Spine of Subject PA 6 Weeks After Ejection Trauma

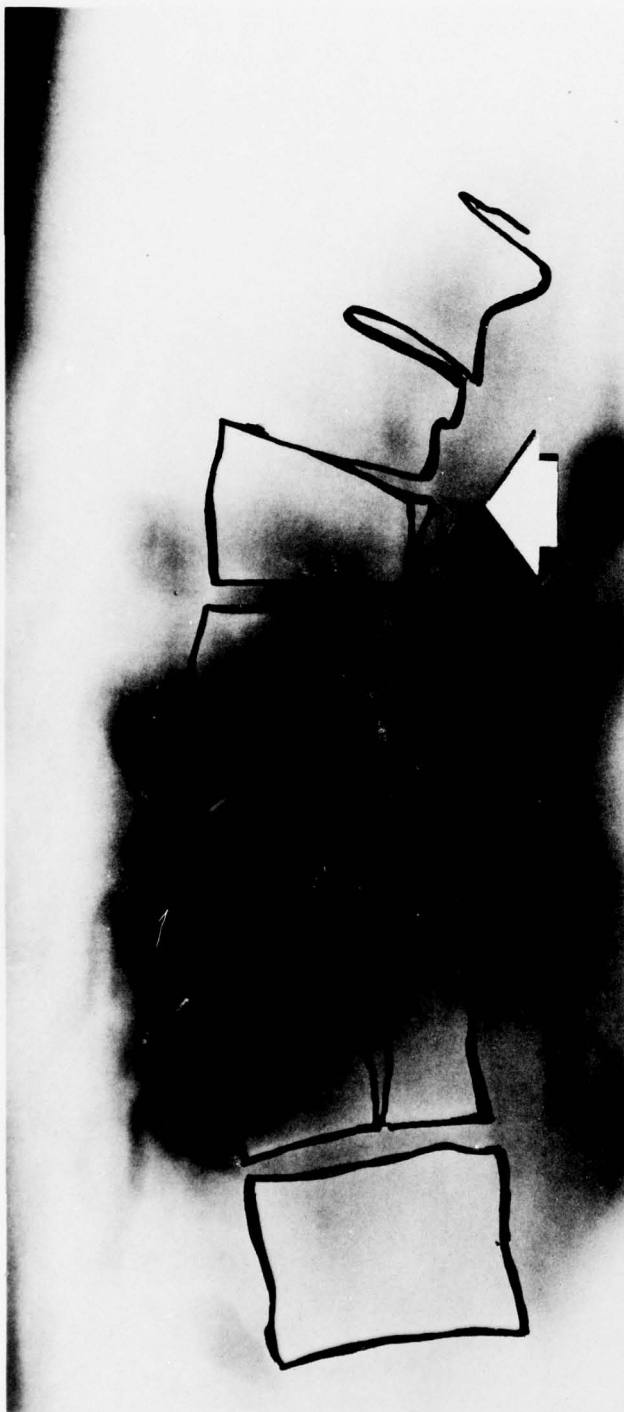
Figure 33. Lateral View of Thoracic Spine of Subject PA 4 Months After Ejection Trauma [Note Loss in Intervertebral Disk Space Height (Arrow)]

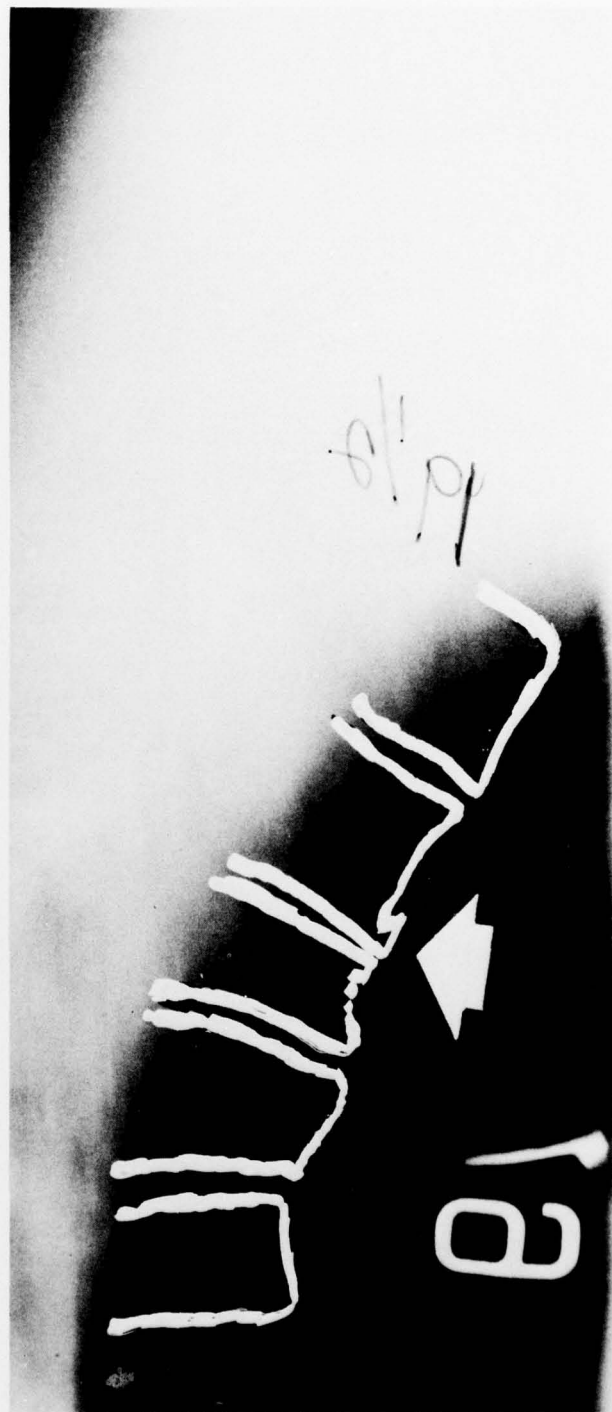
Figure 34. Lateral View of Thoracic Spine of Subject PA 18 Months After Ejection [Arrows Identify Spinal Region Undergoing Spontaneous Anterior Fusion]

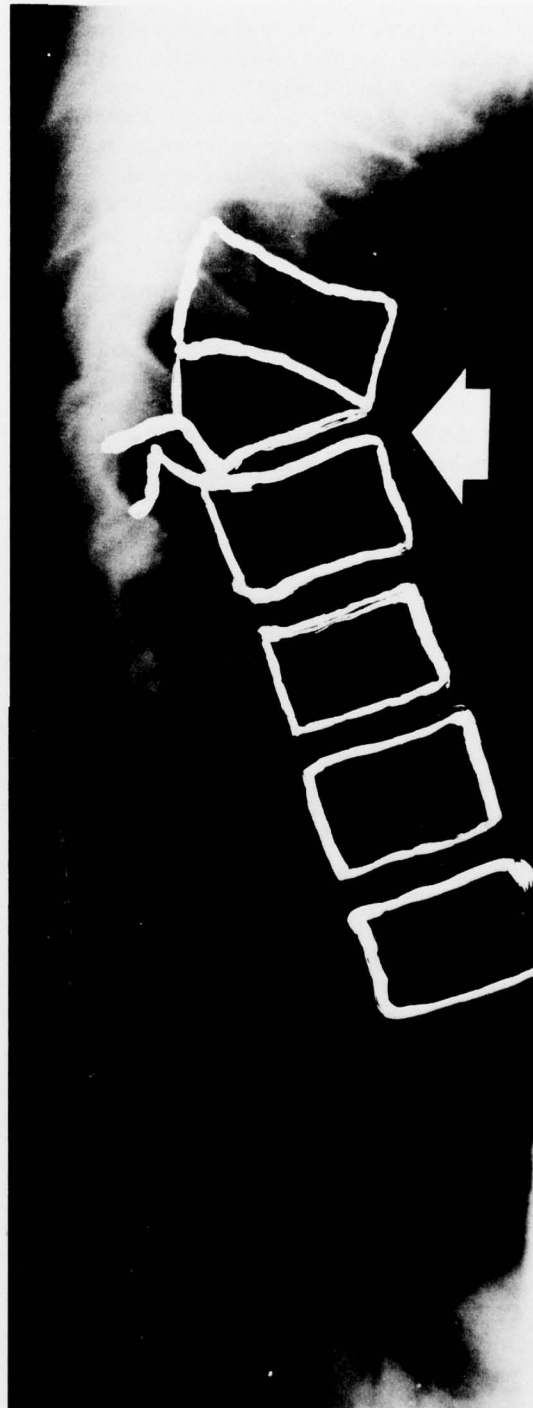
Figure 36. Lateral Roentgenogram of Subject TI 4 Days After Ejection [Arrow Identifies Site of Anterior Wedge Compression Fracture]

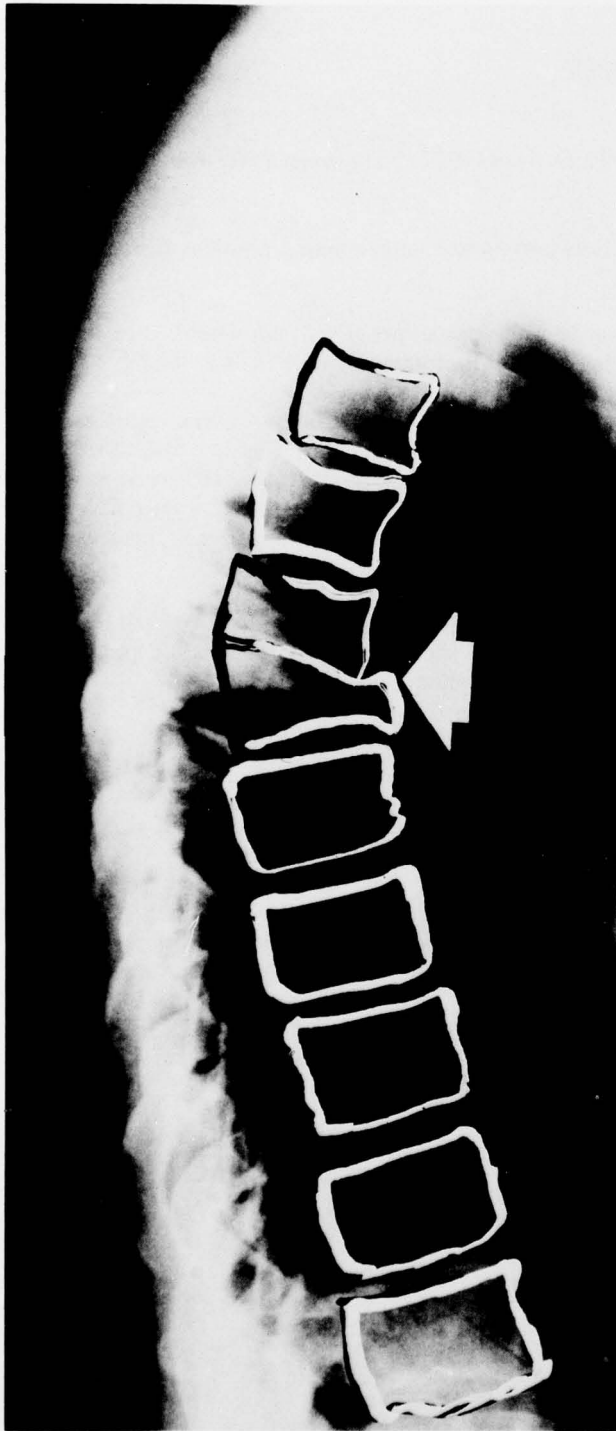
Figure 37. Lateral Roentgenogram of Subject TI 32 Weeks After Spinal Injury [Bony Fragment is Clearly Visible]
